Finance Committee Report

This Emergency Action Plan (EAP) was prepared for the Owner of the Bulloughs Pond Dam in accordance with the Commonwealth of Massachusetts General Laws, M.G.L. 253, Section 44, Chapter 302 C.M.R. 10.00, "Dam Safety, dated February 10, 2017". This EAP establishes a basic plan of action if conditions at the dam indicate the potential for dam failure or if any individual observes and reports that a dangerous condition is developing at the dam. This EAP follows a template developed by the Department of Conservation and Recreation (DCR) Office of Dam Safety (ODS). The development of the template has been primarily based on the Federal Emergency Management Agency (FEMA) "Federal Guidelines for Dam Safety: Emergency Action Planning for Dam Owners," dated October 1998, the Federal Energy Regulatory Commission (FERC) "Emergency Action Plan Guidelines," dated November 1998, 2006 Natural Resources Conservation Service (NRCS) recommendations for developing EAPs, and other publicly available EAP templates from state dam safety programs.

PHASE II REPORT FOR BULLOUGH'S POND DAM

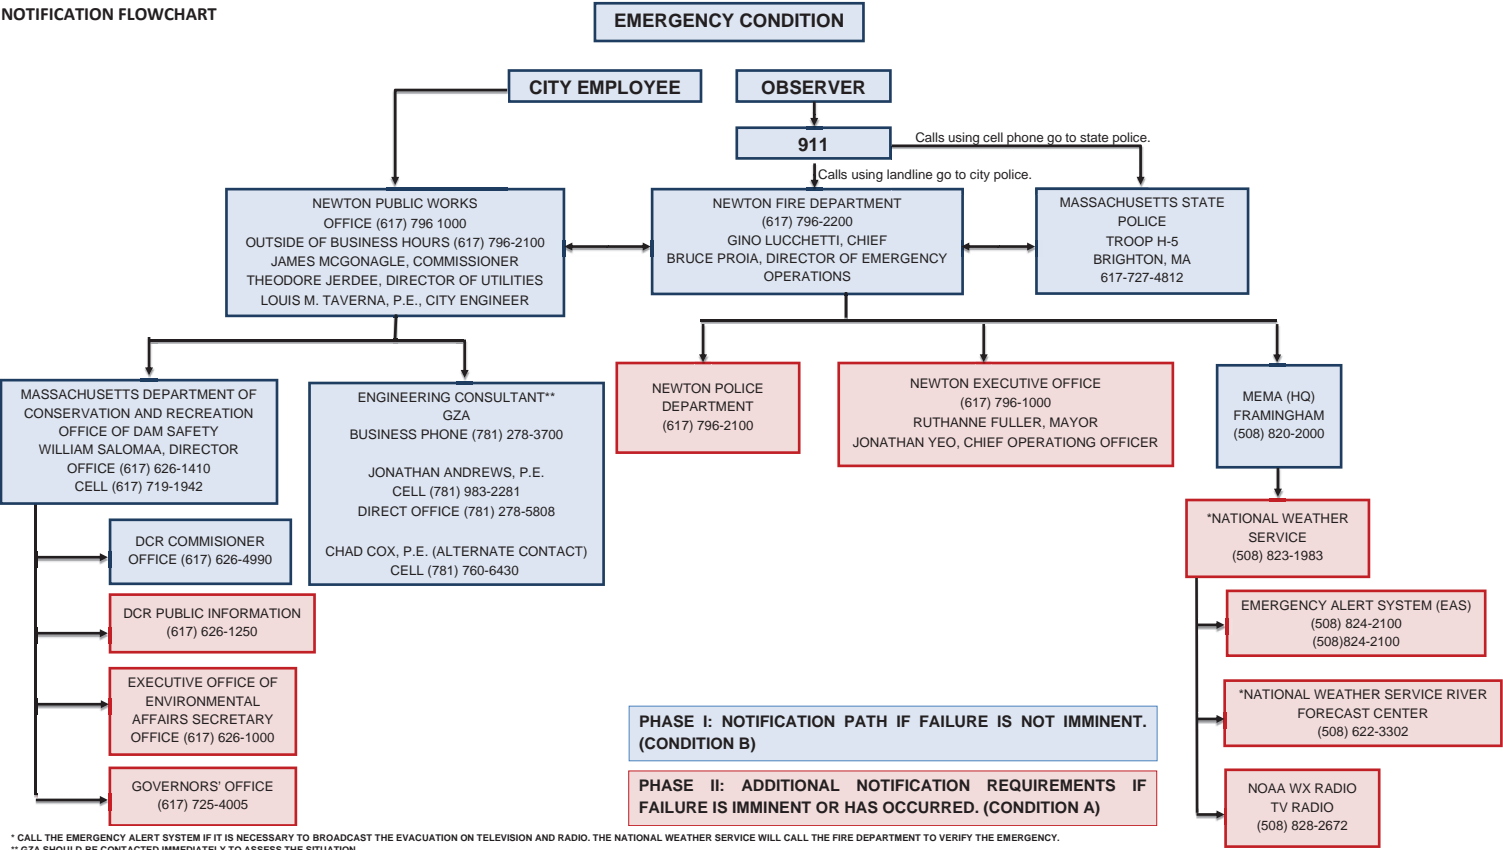
NOTIFICATION FLOWCHART

* CALL THE EMERGENCY ALERT SYSTEM IF IT IS NECESSARY TO BROADCAST THE EVACUATION ON TELEVISION AND RADIO. THE NATIONAL WEATHER SERVICE WILL CALL THE FIRE DEPARTMENT TO VERIFY THE EMERGENCY.

** GZA SHOULD BE CONTACTED IMMEDIATELY TO ASSESS THE SITUATION.

The Notification Flowchart (located after the Preamble) indicates the chain of communication to be followed in the event of an Emergency. The Notification Flowchart indicates a Phase I and Phase II type of notification to be implemented depending on the emergency classification level (Dam Safety Watch or Dam Failure Warning) as determined necessary based upon the judgment of the personnel monitoring the emergency condition at the dam (see Appendix B for additional descriptions).

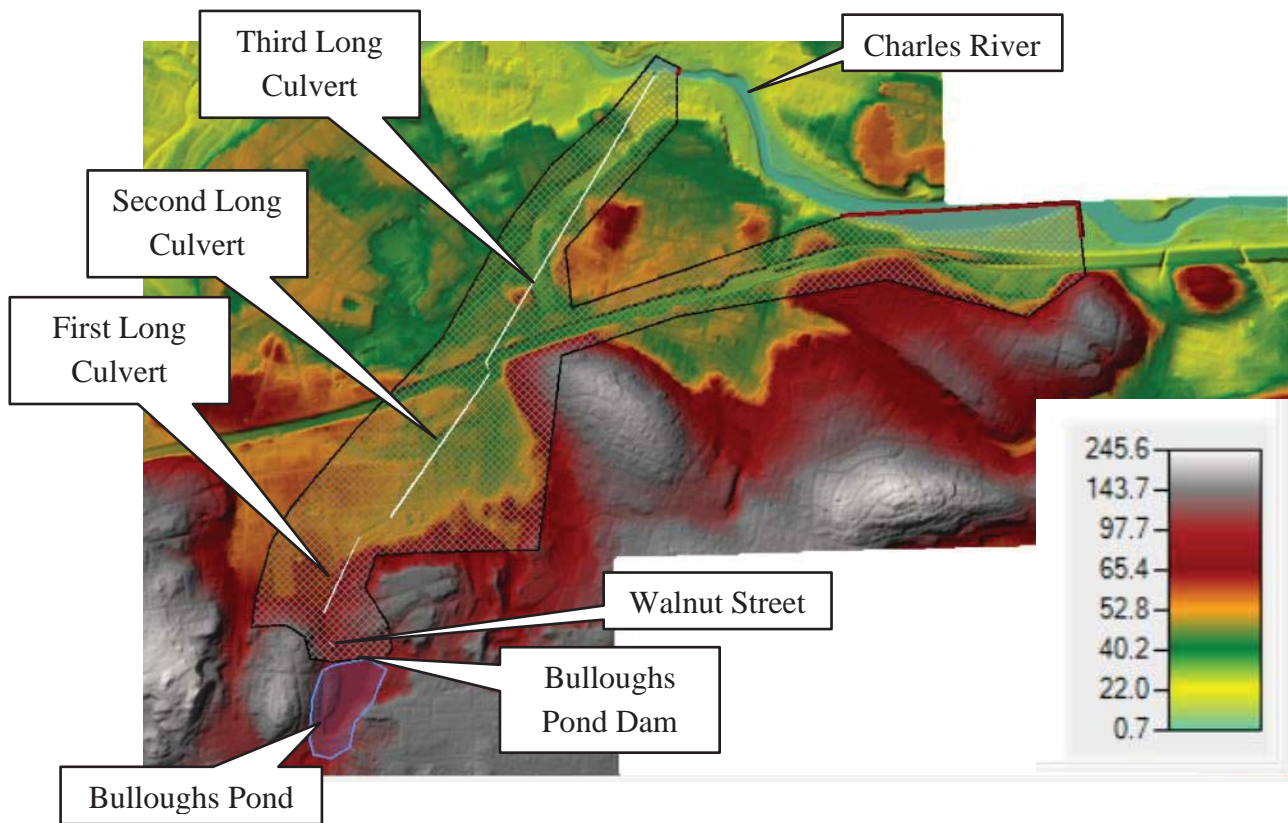
Figure G1: Model Setup with Terrain (Feet, NAVD88)

To evaluate the extent of flooding due to a partial dam failure at Bulloughs Pond Dam, GZA performed a simulation of the hypothetical dam break utilizing HEC-RAS 5.0.7 software. HEC-RAS was developed by the United States Army Corps of Engineers (USACE) Hydrologic Engineering Center. HEC-RAS performs 1-dimensional and 2-dimensional unsteady flow calculations. For the dam break modeling, GZA used the 2-dimensional routine, which uses a network of grid cells to route flows.

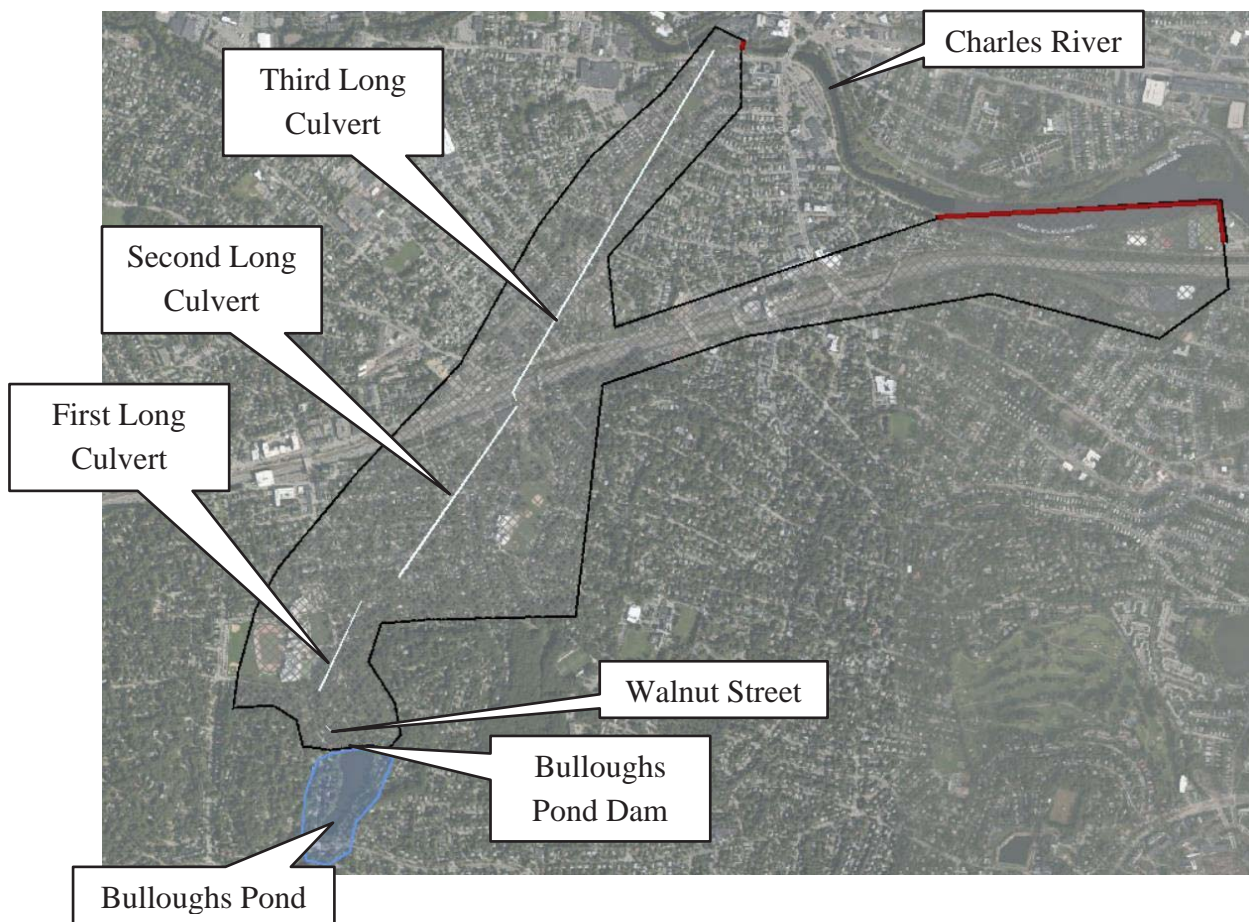
Figure G2: Model Setup with Aerial Imagery

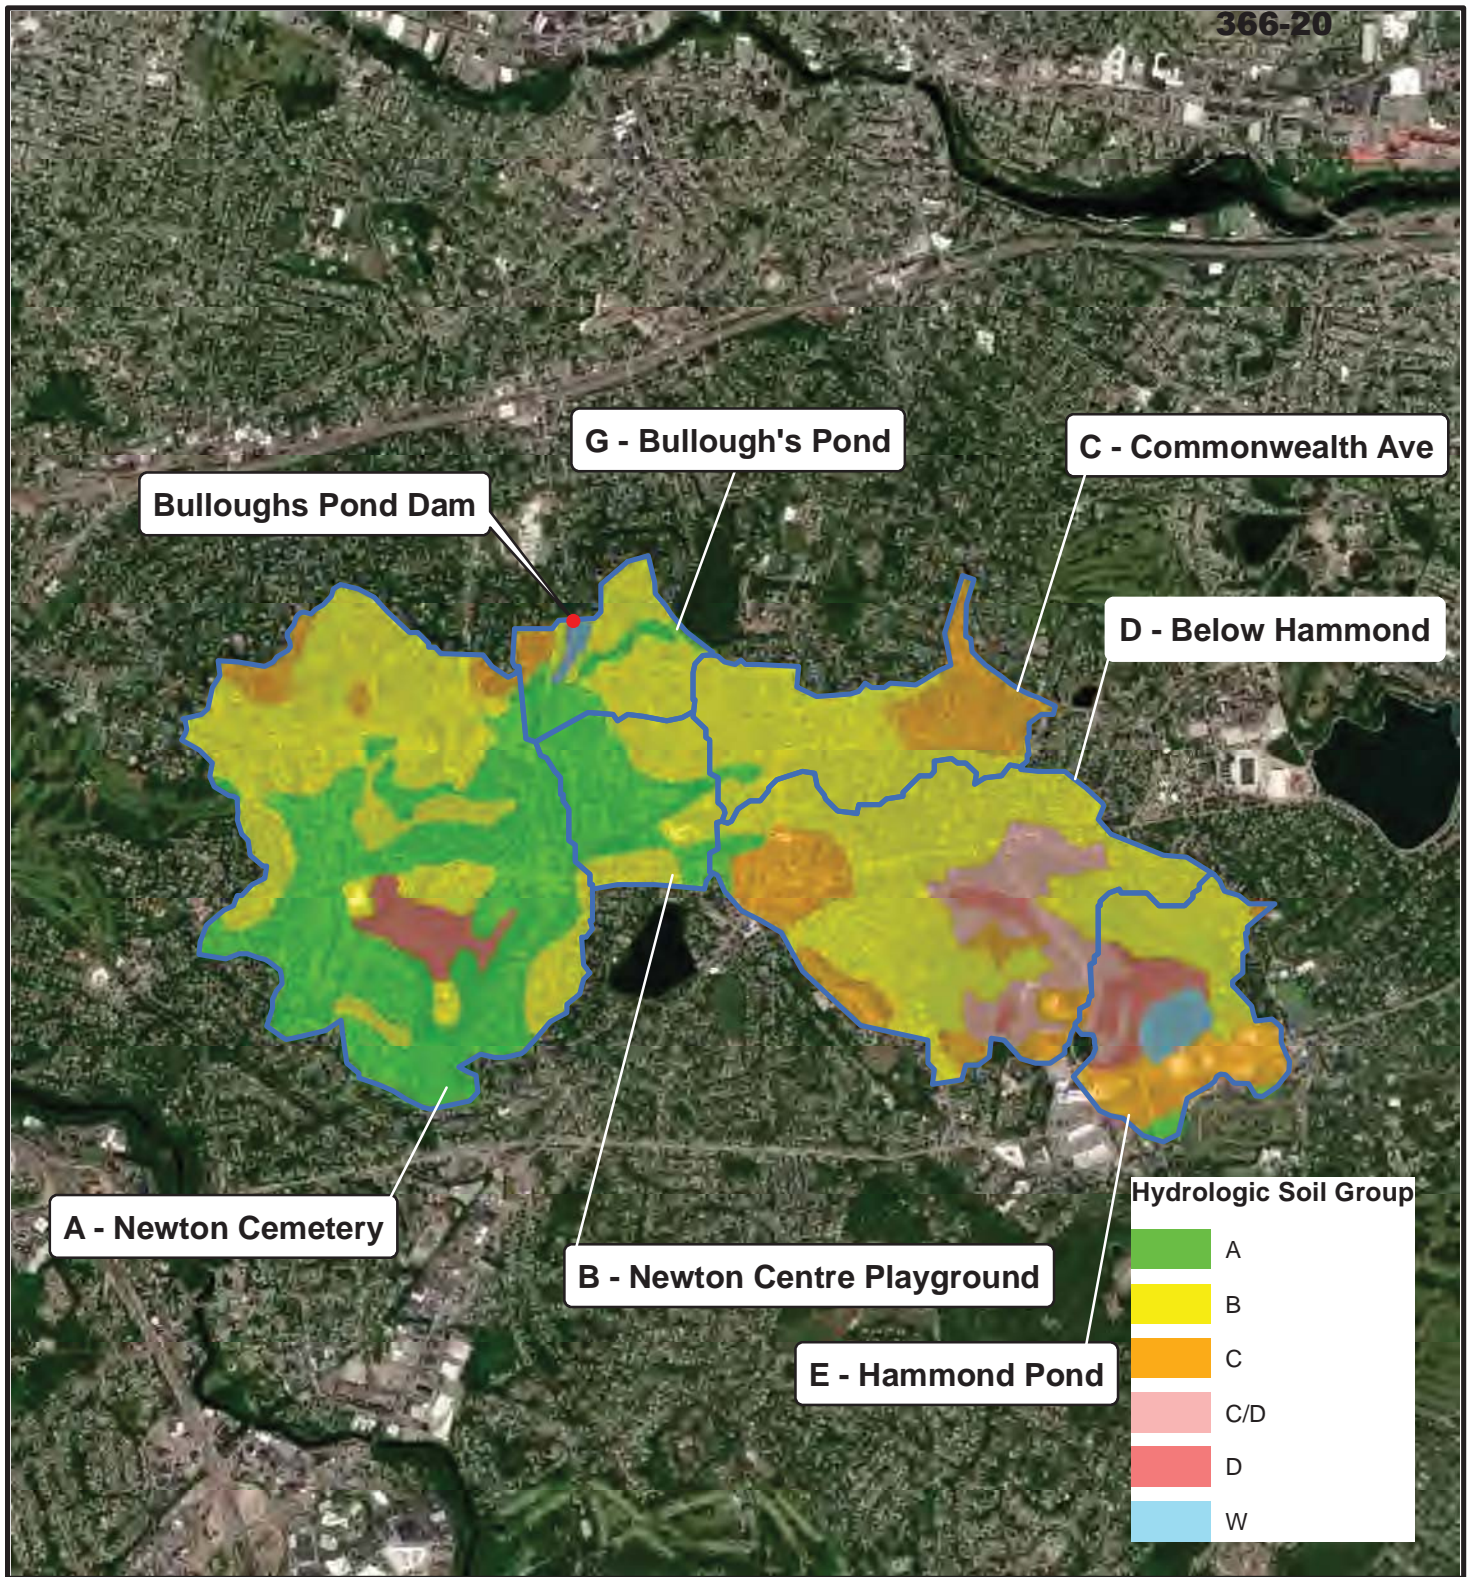
FIGURE NO.
4

THIS MAP CONTAINS AERIAL IMAGERY FROM ESRI, 2017.
SOIL DATA WAS OBTAINED FROM THE USDA/NRCS
WEB SOIL SURVEY (WSS), ACCESSED SEPTEMBER, 2019

GZA delineated the total contributing drainage area of approximately 3.15 square miles using the USGS StreamStats web application and 2013-2014 USGS Sandy LiDAR data published by Massachusetts Geographic Information System (MassGIS). The LiDAR data had a resolution of 1 meter. GZA subdivided the watershed into six sub-watersheds which are shown in **Figure 3**. The watershed is characterized by a varying range of runoff potential soils as well as commercial, residential, and recreational (parks) land uses. The City of Newton is densely populated with a large amount of impervious area and the impervious areas are considered connected as its runoff flows directly into a drainage system, as defined in Chapter 9 of the NRCS National Engineering Handbook (NEH) Part 630 Hydrology (NRCS, 2004). The characterization of soil types within the drainage area is shown in **Figure 4**.

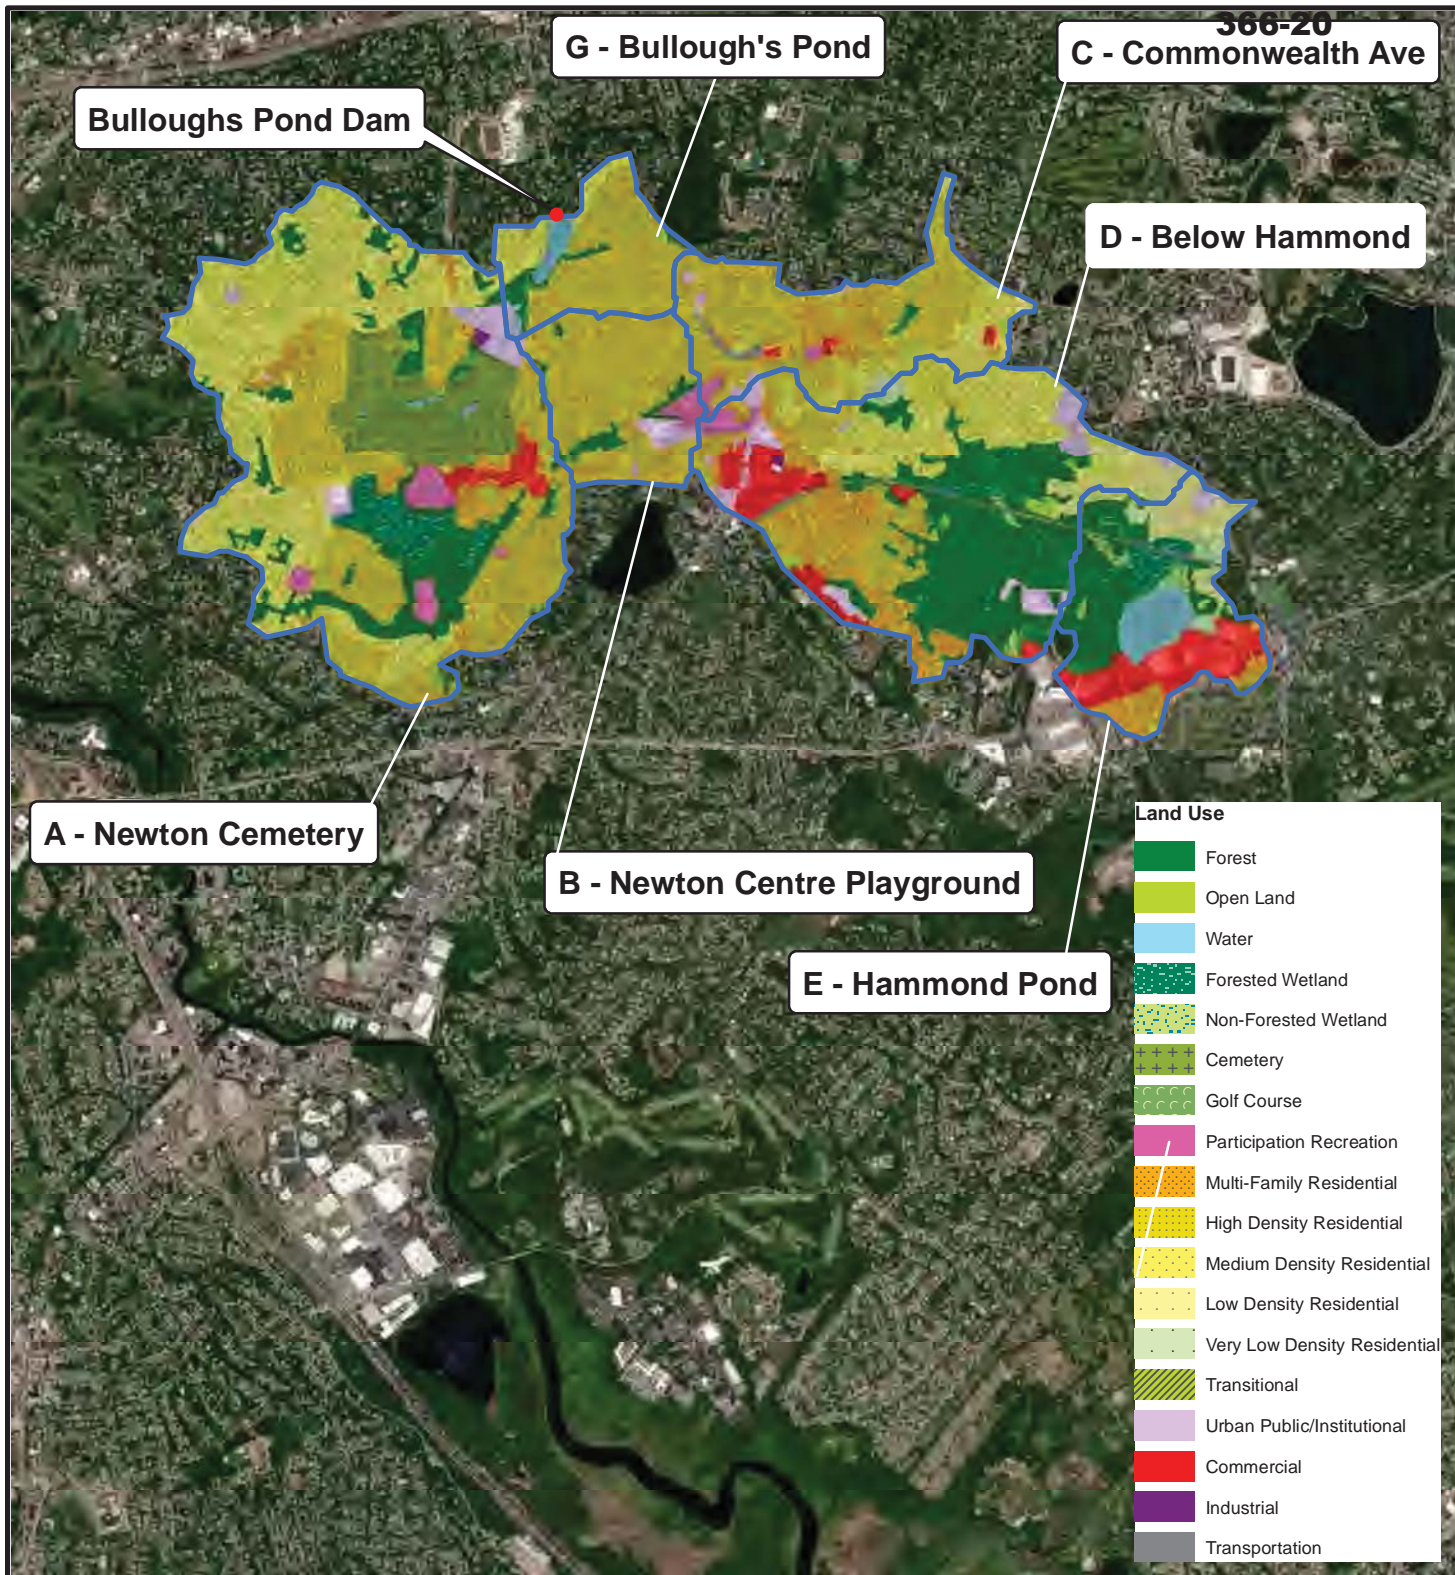
FIGURE NO.
5

THIS MAP CONTAINS AERIAL IMAGERY FROM ESRI, 2017.
LAND USE DATA WAS RETRIEVED FROM MASS GIS, PUBLISHED IN 2005

The Curve Number (CN) Method was used to model infiltration. The CN is assigned based on hydrologic soil group (A, B, C or D, from lowest to highest runoff potential) and land cover type based on guidance in Chapter 9 of the NRCS NEH Part 630 Hydrology (NRCS, 2004). The hydrologic soil group classification was obtained from the 2017 Norfolk and Suffolk Counties Soil Data GIS shapefile available from the NRCS Web Soil Survey. The land cover data was obtained from the 2005 Massachusetts Land Use GIS shapefile available on the MassGIS website. The resultant CN for the subwatersheds are provided in **Table 6.2** below. The land use categories within the watershed are shown in **Figure 5**. Curve number computations are included in **Appendix H**.

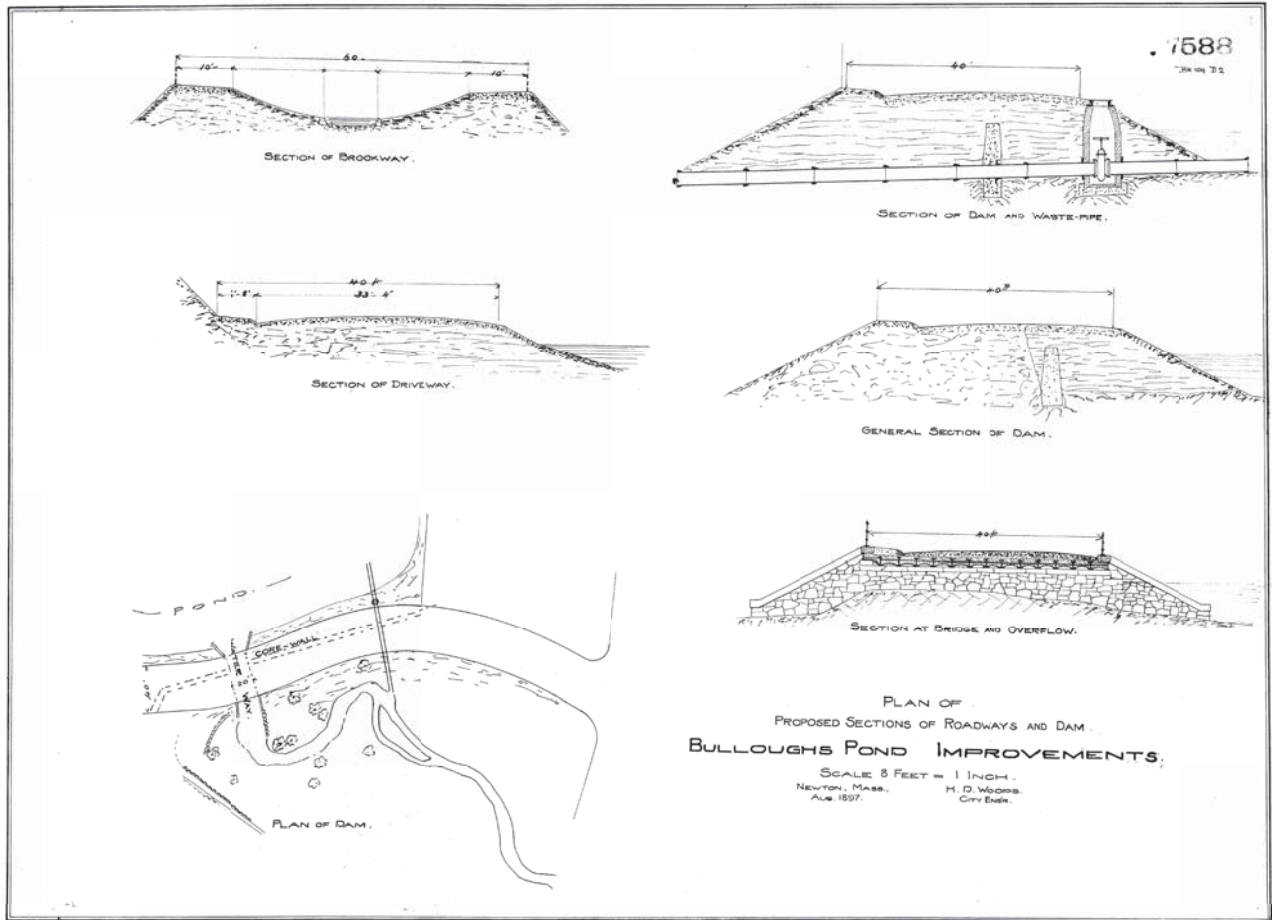
PLAN AND PROFILE OF DRAIN IN
WALNUT ST.
 LAUNDRY BROOK TO MILL ST.
MILL ST.
 WALNUT ST. WOODSIDE RD.
 Horizontal Scale: 1" = 10'
 Vertical Scale: 1" = 10'
 Newton Mass. December 1904.
 Irving T. Barnham City Eng'r.

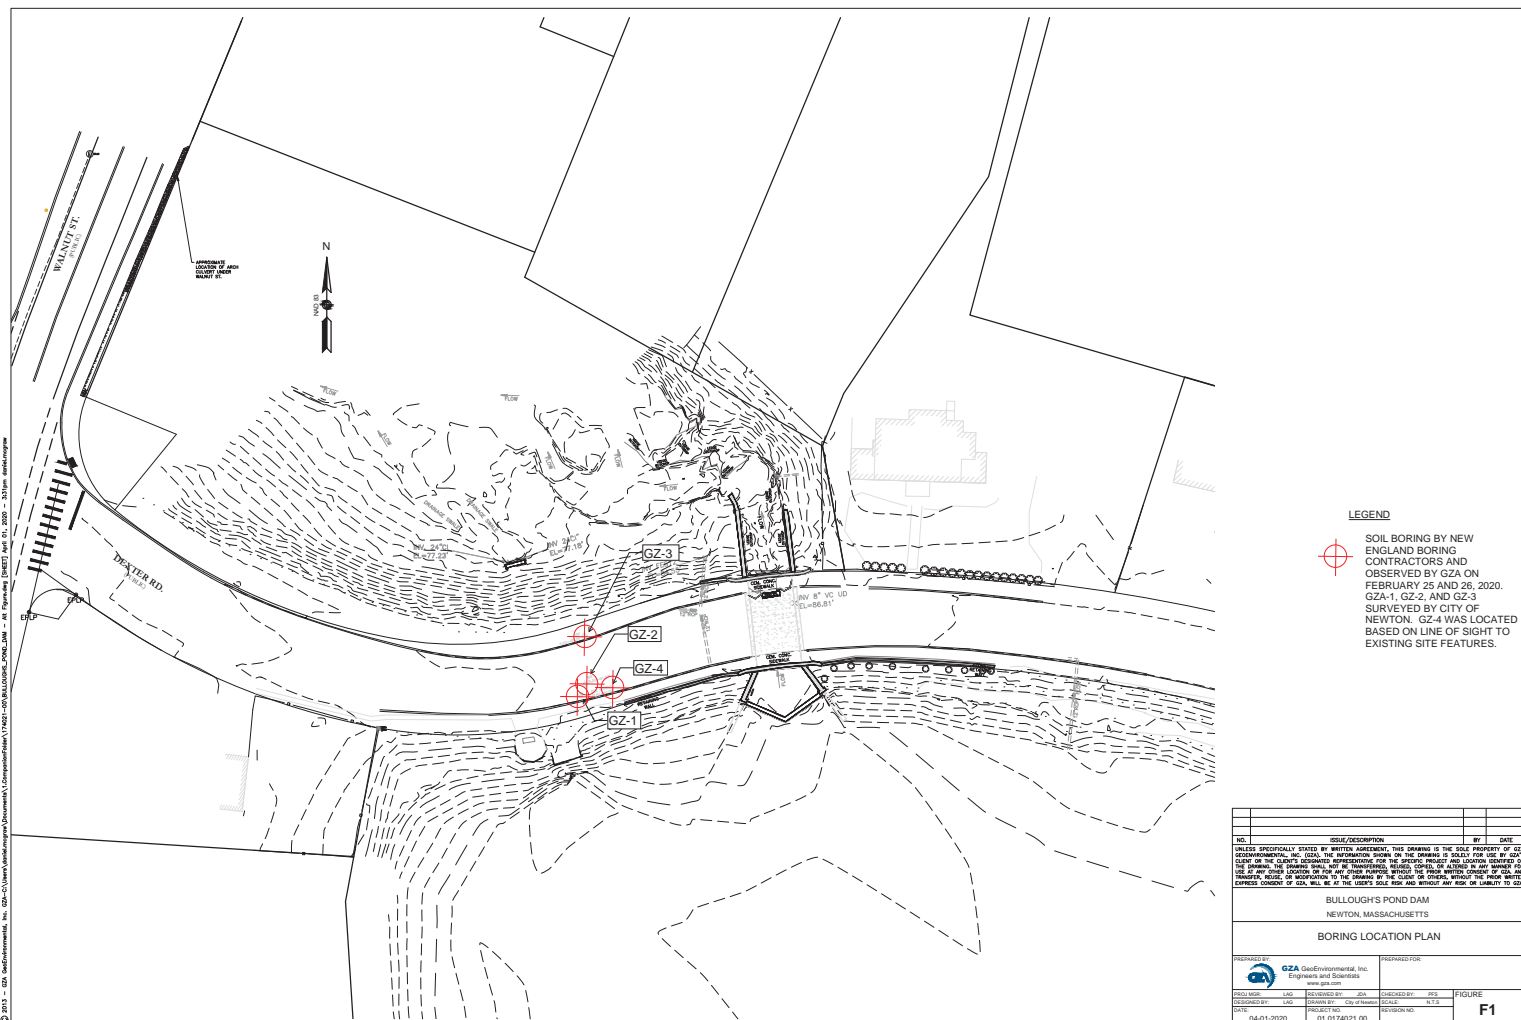
TEST BORING LOG

GZA GeoEnvironmental, Inc. <i>Engineers and Scientists</i>		City of Newton DPW Bulloughs Pond Dam Phase II Dexter Road Newton, Massachusetts		BORING NO.: GZ-1 SHEET: 1 of 1 PROJECT NO: 01.0174021.00 REVIEWED BY:																										
Drilling Co.: New England Boring Contractors Foreman: Gary Twombly Logged By: Cody Gibb		Type of Rig: Truck Rig Model: CME 75 Drilling Method: Drive & Wash		Boring Location: See Plan Ground Surface Elev. (ft.): 91.82 Final Boring Depth (ft.): 12 Date Start - Finish: 2/25/2019 - 2/25/2019																										
H. Datum: See Plan V. Datum: NAVD88																														
Auger/Casing Type: HW I.D./O.D.(in): 4"/4.5" Hammer Weight (lb.): 300 Hammer Fall (in.): 24 Other: Safety Hammer		Sampler Type: Split Spoon I.D./O.D. (in.): 1.375"/2" Sampler Hmr Wt (lb): 140 Sampler Hmr Fall (in): 30 Other: Auto Hammer

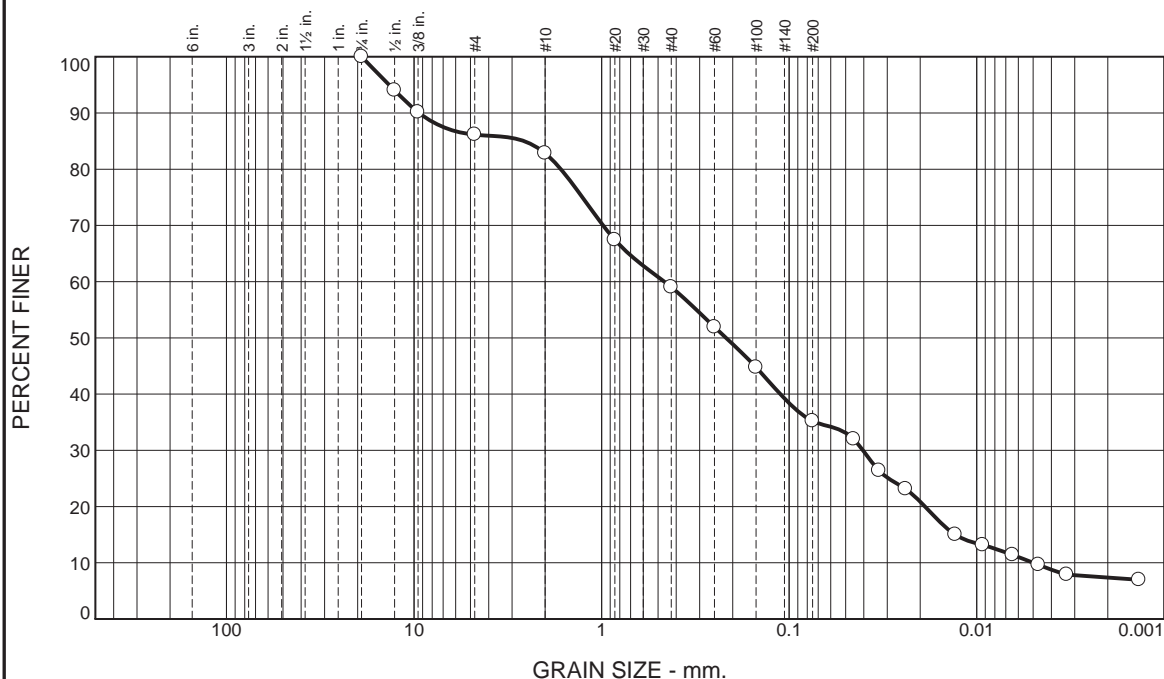
Particle Size Distribution Report

% +3"	% Gravel		% Sand			% Fines	
	Coarse	Fine	Coarse	Medium	Fine	Silt	Clay
0.0	0.0	13.9	3.2	23.9	23.8	27.8	7.4

Test Results (D7928 & ASTM D 1140)			
Opening Size	Percent Finer	Spec.* (Percent)	Pass? (X=Fail)
0.75"	100.0		
0.5"	94.0		
0.375"	90.2		
#4	86.1		
#10	82.9		
#20	67.4		
#40	59.0		
#60	51.9		
#100	44.8		
#200	35.2		
0.0453 mm.	32.0		
0.0332 mm.	26.4		
0.0239 mm.	23.1		
0.0130 mm.	15.0		
0.0093 mm.	13.2		
0.0064 mm.	11.4		
0.0047 mm.	9.6		
0.0033 mm.	7.9		
0.0014 mm.	7.0

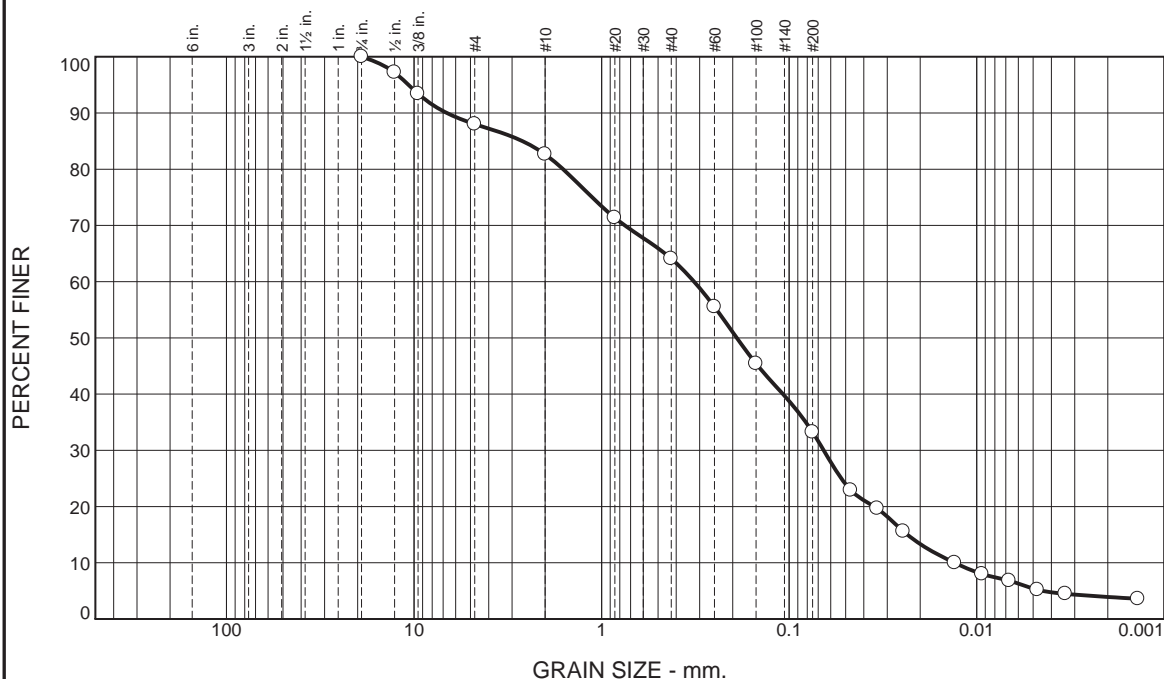
Figure S-1

Particle Size Distribution Report

% +3"	% Gravel		% Sand			% Fines	
	Coarse	Fine	Coarse	Medium	Fine	Silt	Clay
0.0	0.0	12.0	5.4	18.5	30.9	29.3	3.9

Test Results (D7928 & ASTM D 1140)			
Opening Size	Percent Finer	Spec.* (Percent)	Pass? (X=Fail)
0.75"	100.0		
0.5"	97.2		
0.375"	93.4		
#4	88.0		
#10	82.6		
#20	71.4		
#40	64.1		
#60	55.5		
#100	45.4		
#200	33.2		
0.0469 mm.	22.9		
0.0339 mm.	19.6		
0.0246 mm.	15.6		
0.0131 mm.	10.0		
0.0094 mm.	8.0		
0.0067 mm.	6.8		
0.0047 mm.	5.2		
0.0034 mm.	4.5		
0.0014 mm.	3.6

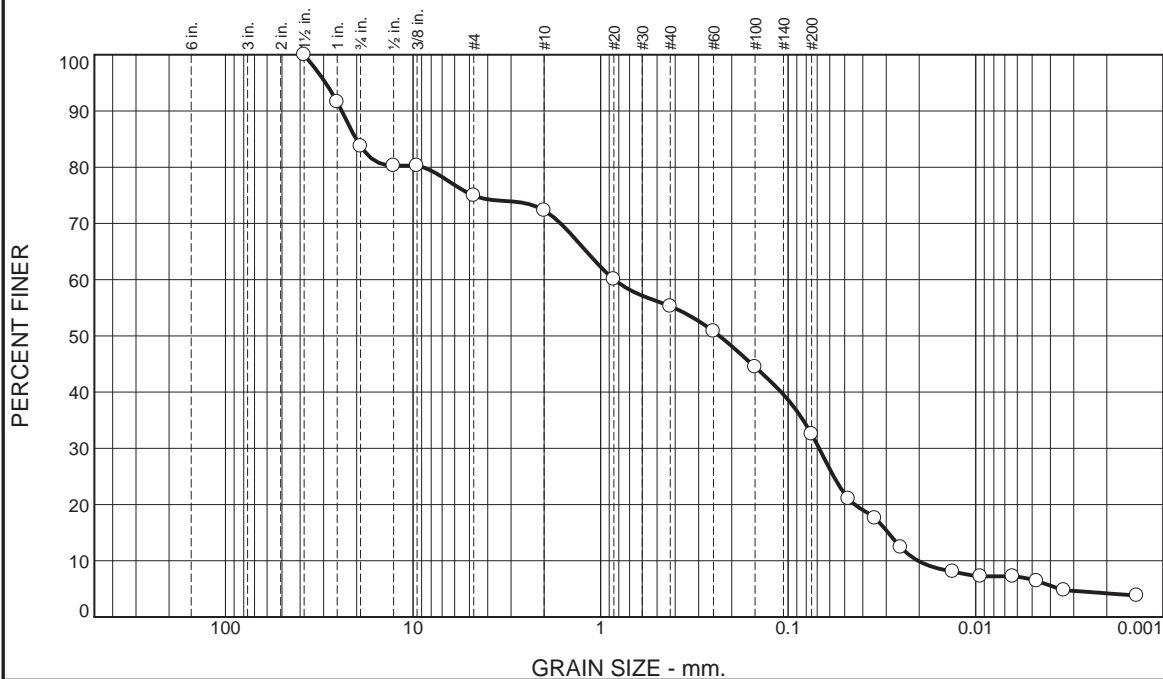
Figure S-2

Particle Size Distribution Report

% +3"	% Gravel		% Sand			% Fines	
	Coarse	Fine	Coarse	Medium	Fine	Silt	Clay
0.0	16.3	8.7	2.7	17.0	22.8	28.3	4.2

Test Results (D7928 & ASTM D 1140)			
Opening Size	Percent Finer	Spec.* (Percent)	Pass? (X=Fail)
1-1/2"	100.0		
1"	91.6		
3/4"	83.7		
1/2"	80.3		
3/8"	80.3		
#4	75.0		
#10	72.3		
#20	60.1		
#40	55.3		
#60	50.8		
#100	44.5		
#200	32.5		
0.0478 mm.	21.0		
0.0345 mm.	17.6		
0.0251 mm.	12.4		
0.0133 mm.	8.1		
0.0094 mm.	7.2		
0.0064 mm.	7.2		
0.0047 mm.	6.4		
0.0034 mm.	4.8		
0.0014 mm.	3.8

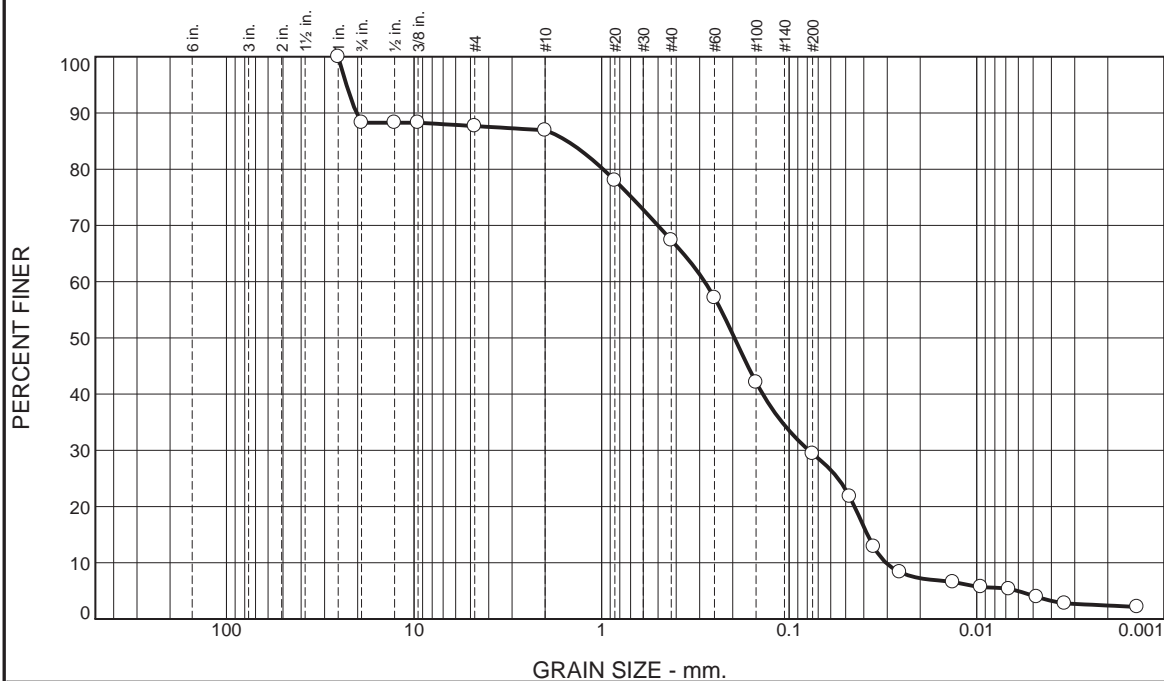
Figure S-3

Particle Size Distribution Report

% +3"	% Gravel		% Sand			% Fines	
	Coarse	Fine	Coarse	Medium	Fine	Silt	Clay
0.0	11.7	0.6	0.8	19.5	38.0	27.0	2.4

Test Results (D7928 & ASTM D 1140)			
Opening Size	Percent Finer	Spec.* (Percent)	Pass? (X=Fail)
1"	100.0		
0.75"	88.3		
0.5"	88.3		
0.375"	88.3		
#4	87.7		
#10	86.9		
#20	78.0		
#40	67.4		
#60	57.1		
#100	42.1		
#200	29.4		
0.0476 mm.	21.8		
0.0354 mm.	12.9		
0.025 mm.	8.4		
0.0134 mm.	6.6		
0.0095 mm.	5.7		
0.0067 mm.	5.3		
0.0048 mm.	3.9		
0.0034 mm.	2.8		
0.0014 mm.	2.2

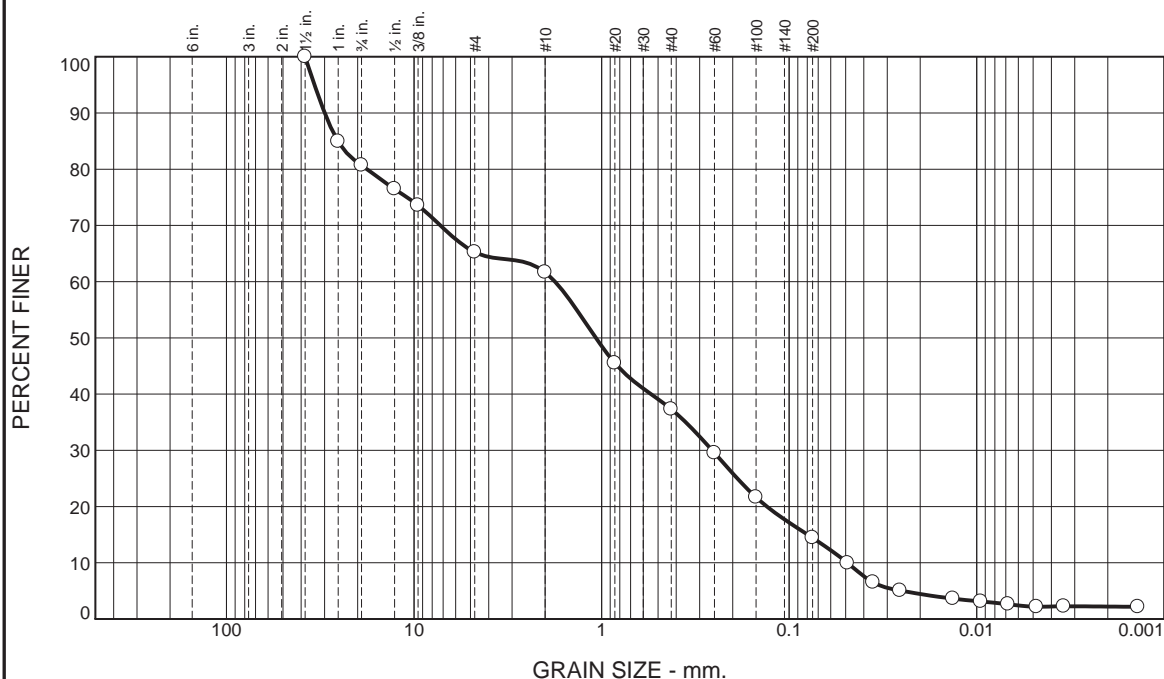
Figure S-4

Particle Size Distribution Report

% +3"	% Gravel		% Sand			% Fines	
	Coarse	Fine	Coarse	Medium	Fine	Silt	Clay
0.0	19.3	15.5	3.5	24.4	22.9	12.2	2.2

Test Results (D7928 & ASTM D 1140)			
Opening Size	Percent Finer	Spec.* (Percent)	Pass? (X=Fail)
1-1/2"	100.0		
1"	84.9		
3/4"	80.7		
1/2"	76.5		
3/8"	73.6		
#4	65.2		
#10	61.7		
#20	45.5		
#40	37.3		
#60	29.5		
#100	21.6		
#200	14.4		
0.0488 mm.	9.9		
0.0357 mm.	6.5		
0.0256 mm.	5.1		
0.0134 mm.	3.6		
0.0095 mm.	3.1		
0.0068 mm.	2.6		
0.0048 mm.	2.2		
0.0034 mm.	2.3		
0.0014 mm.	2.2

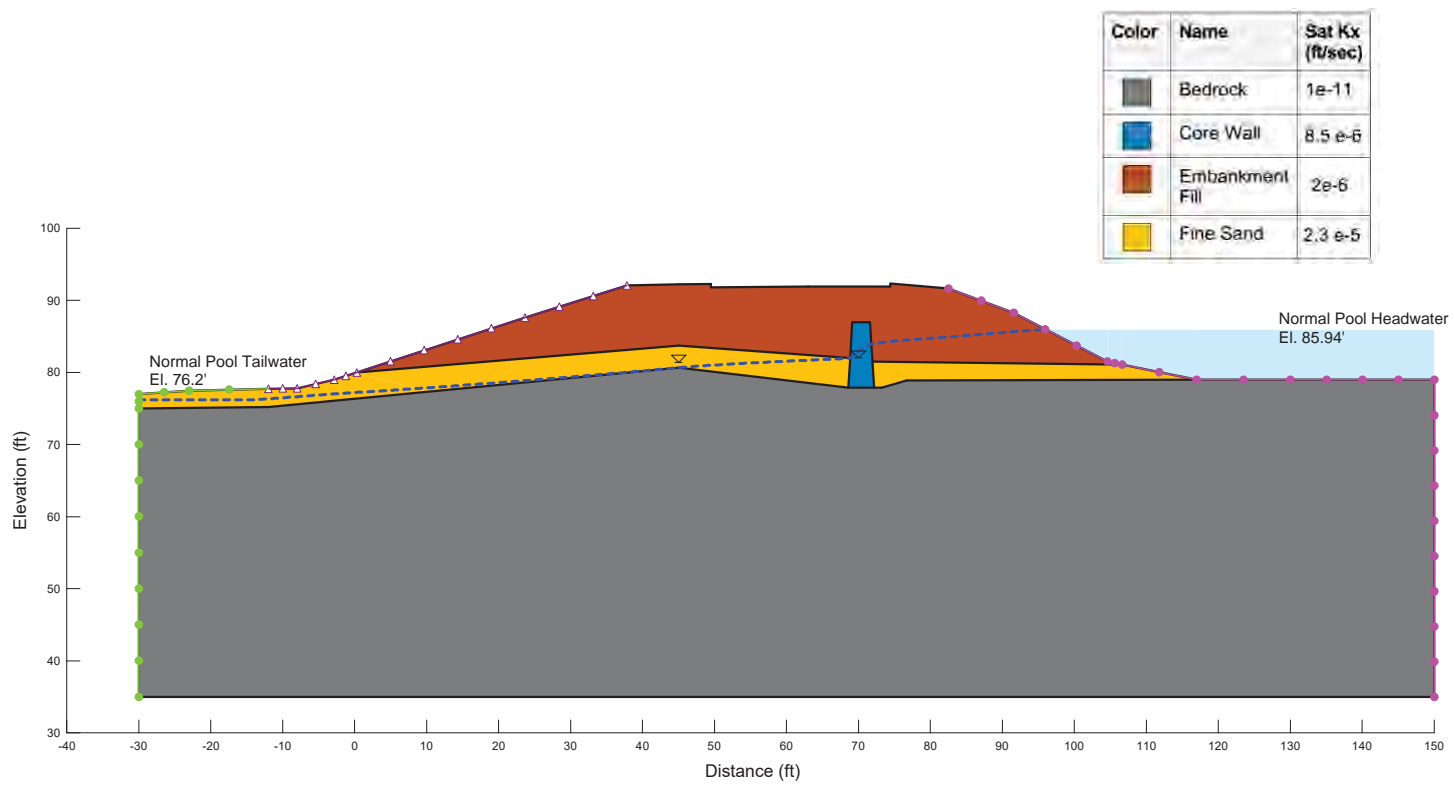
FIGURE

Seepage Analysis - Normal Pool

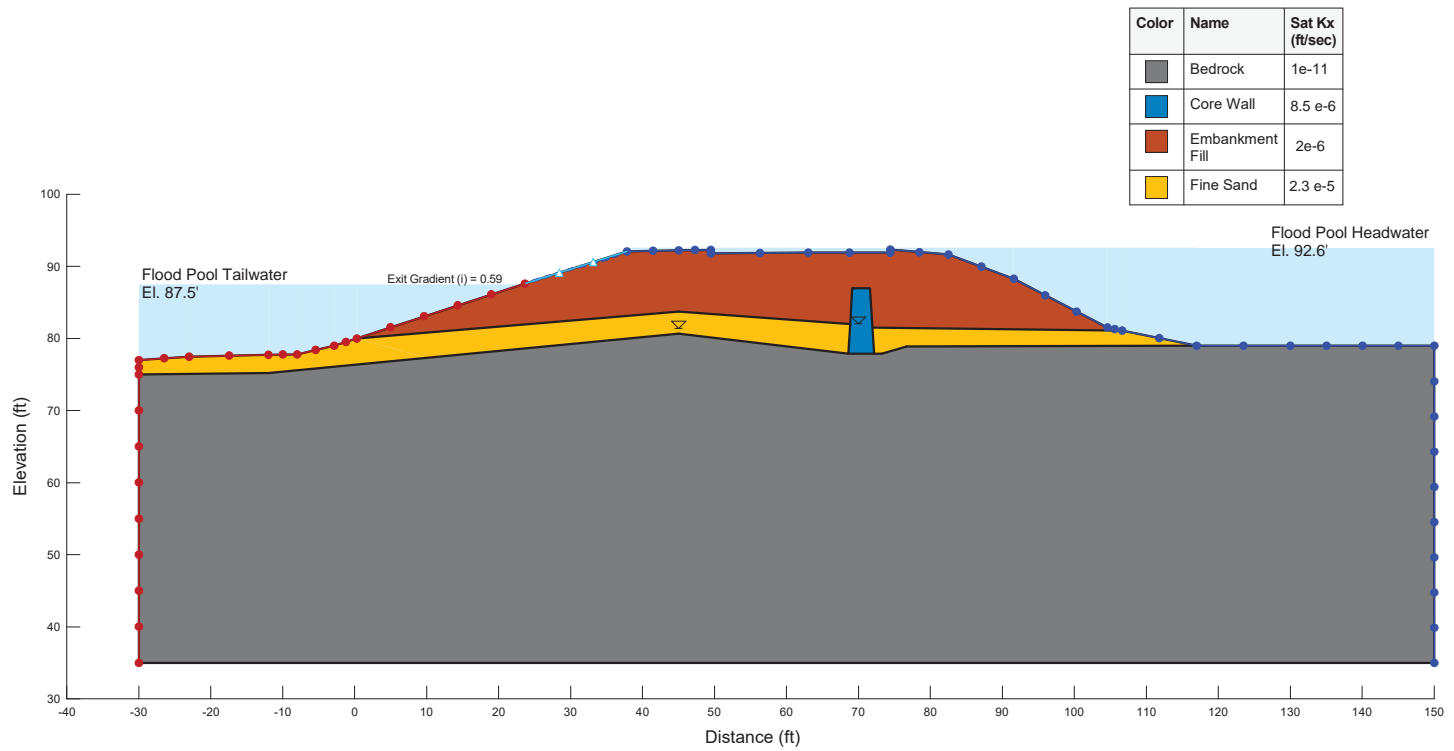
FIGURE

Seepage Analysis - Flood Pool

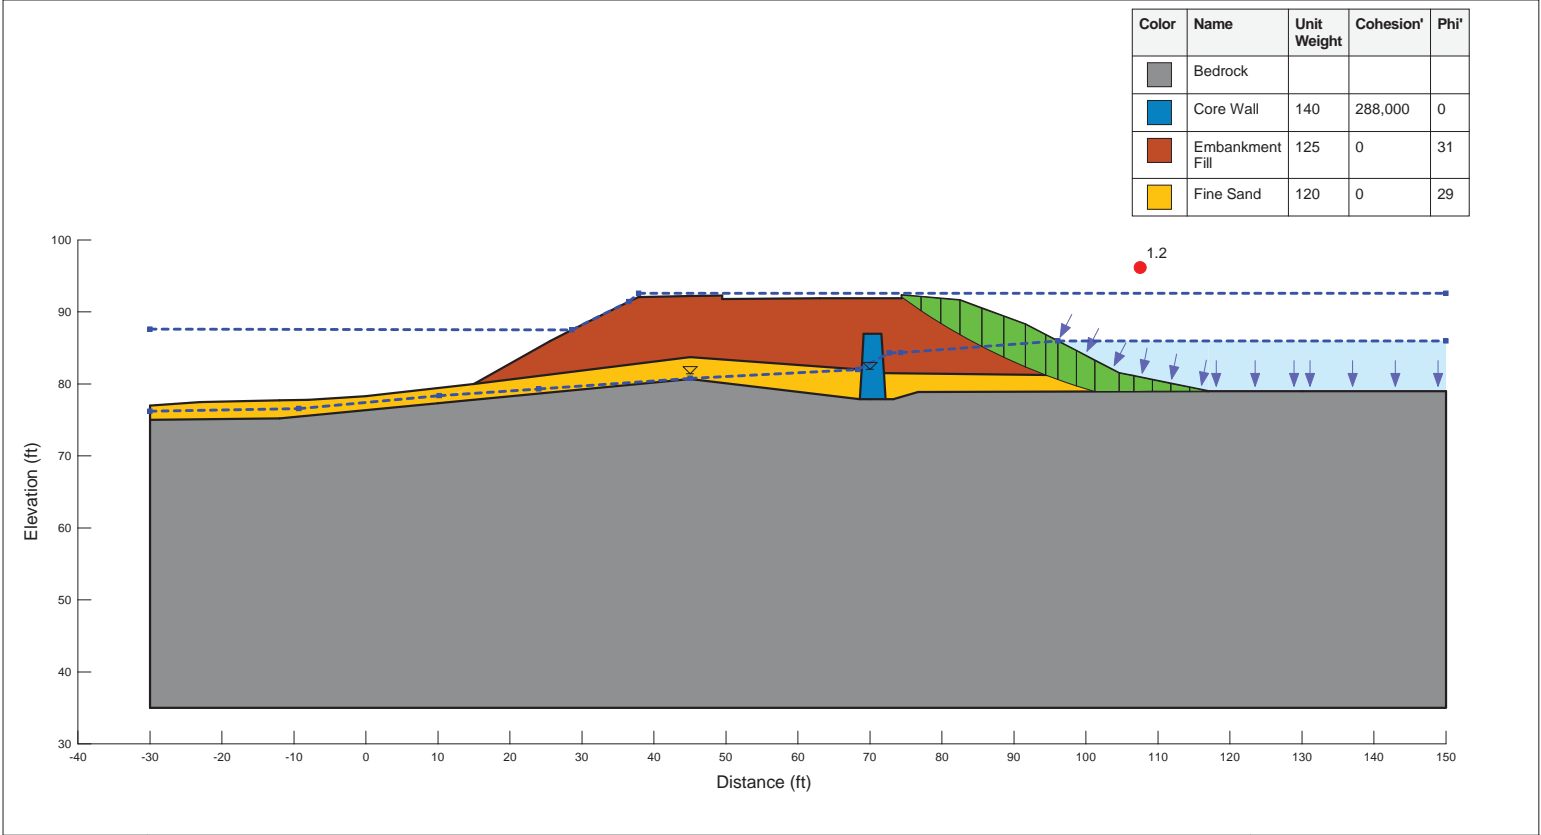
04/22/2020	Phase II For Bulloughs Pond Dam Newton, MA	FIGURE G-1
Upstream Stability - Rapid Drawdown from Flood Pool

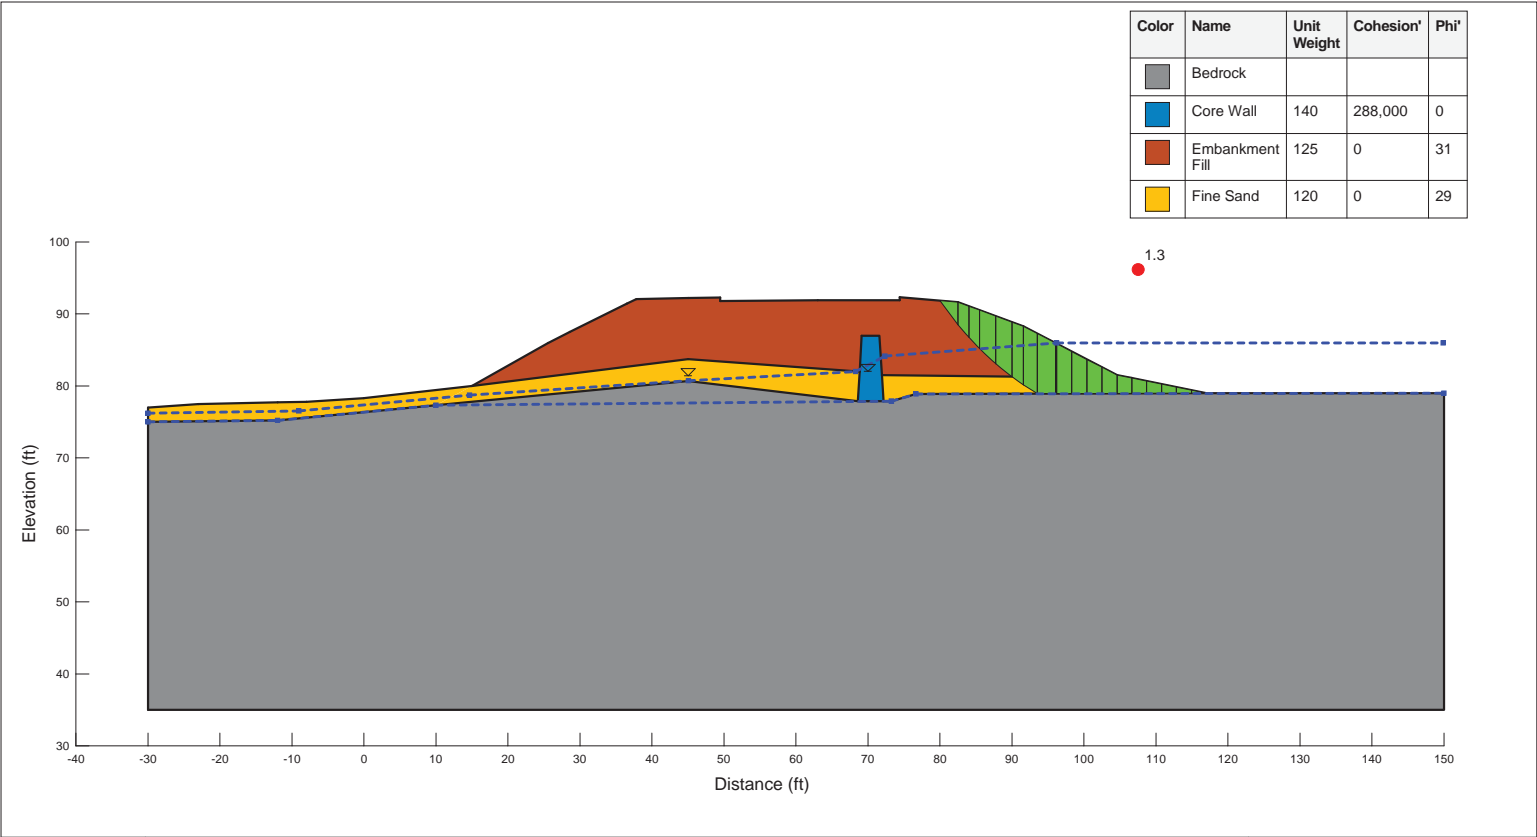
04/22/2020	Phase II For Bulloughs Pond Dam Newton, MA	FIGURE G-2

Upstream Stability - Rapid Drawdown from Normal Pool
