Finance Committee Report

This Emergency Action Plan (EAP) was prepared for the Owner of the Bulloughs Pond Dam in accordance with the Commonwealth of Massachusetts General Laws, M.G.L. 253, Section 44, Chapter 302 C.M.R. 10.00, "Dam Safety, dated February 10, 2017". This EAP establishes a basic plan of action if conditions at the dam indicate the potential for dam failure or if any individual observes and reports that a dangerous condition is developing at the dam. This EAP follows a template developed by the Department of Conservation and Recreation (DCR) Office of Dam Safety (ODS). The development of the template has been primarily based on the Federal Emergency Management Agency (FEMA) "Federal Guidelines for Dam Safety: Emergency Action Planning for Dam Owners," dated October 1998, the Federal Energy Regulatory Commission (FERC) "Emergency Action Plan Guidelines," dated November 1998, 2006 Natural Resources Conservation Service (NRCS) recommendations for developing EAPs, and other publicly available EAP templates from state dam safety programs.

PHASE II REPORT FOR BULLOUGH'S POND DAM

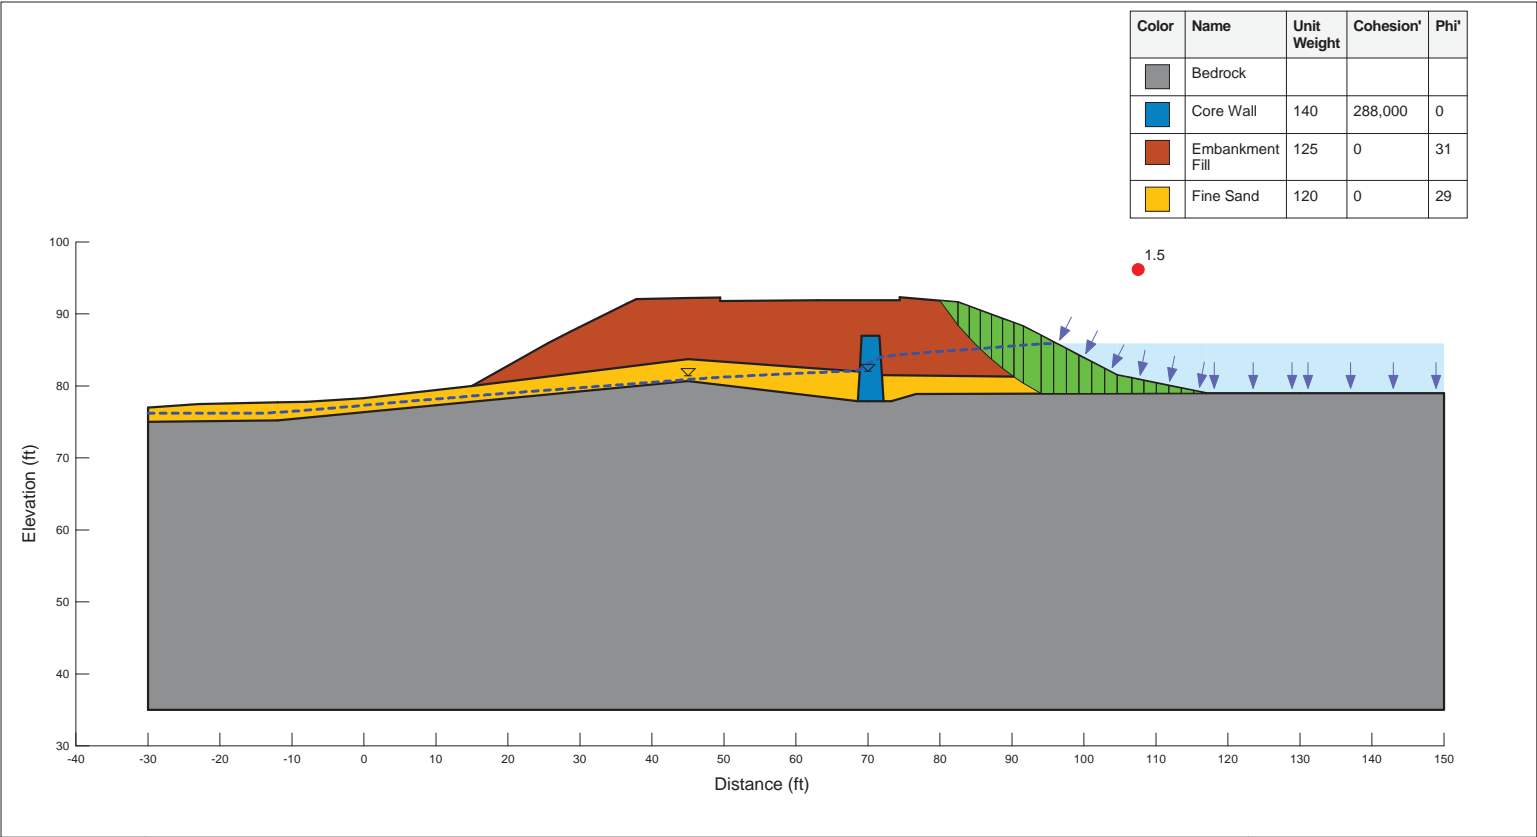
04/22/2020	Phase II For Bulloughs Pond Dam Newton, MA	FIGURE G-3
Upstream Stability - Normal Pool

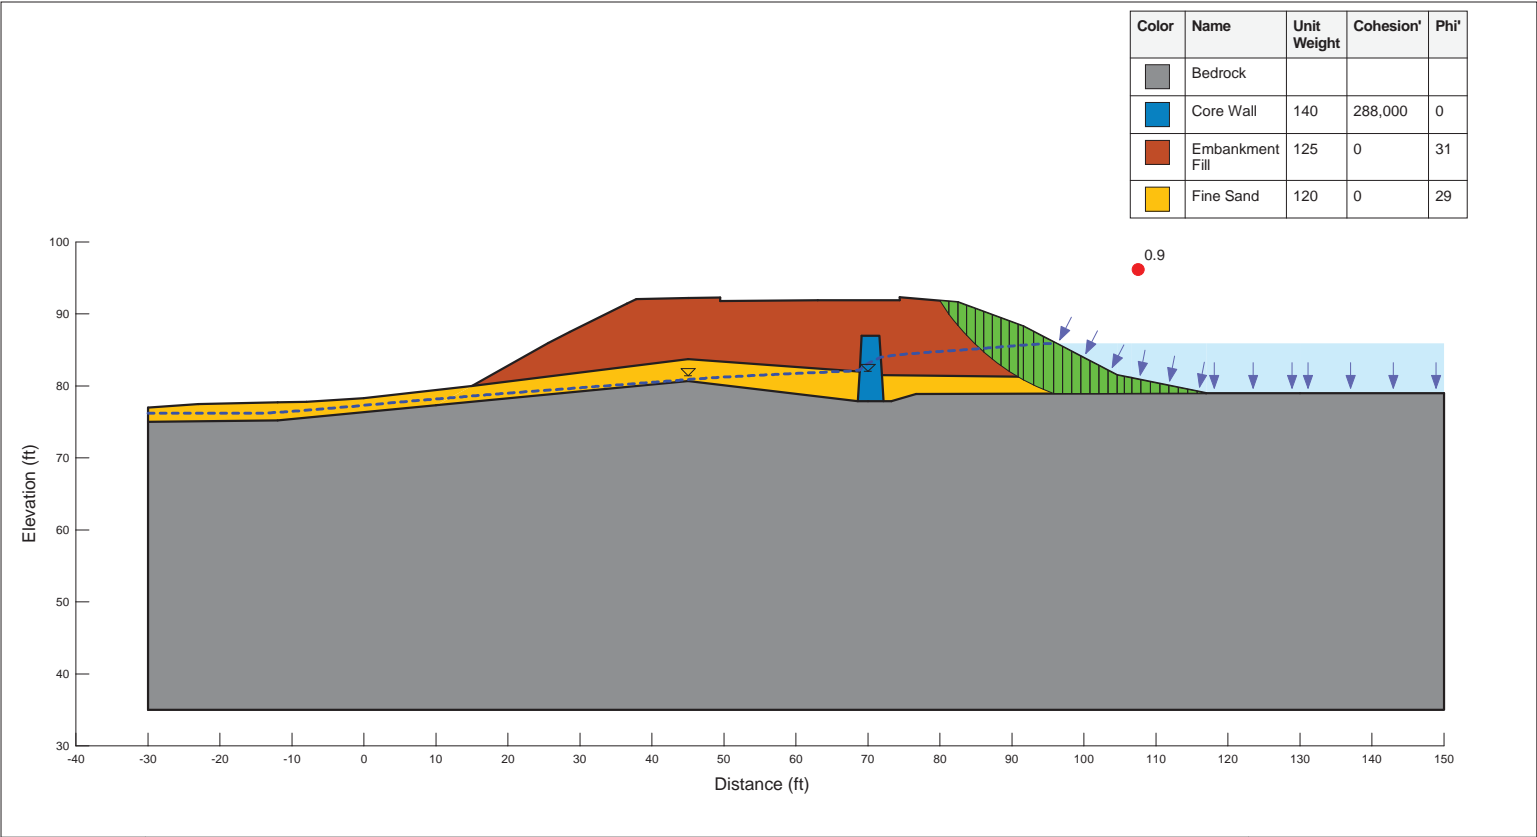
04/22/2020	Phase II For Bulloughs Pond Dam Newton, MA	FIGURE G-7

Upstream Stability - Flood Pool (Psuedo-static Ag = 0.216)

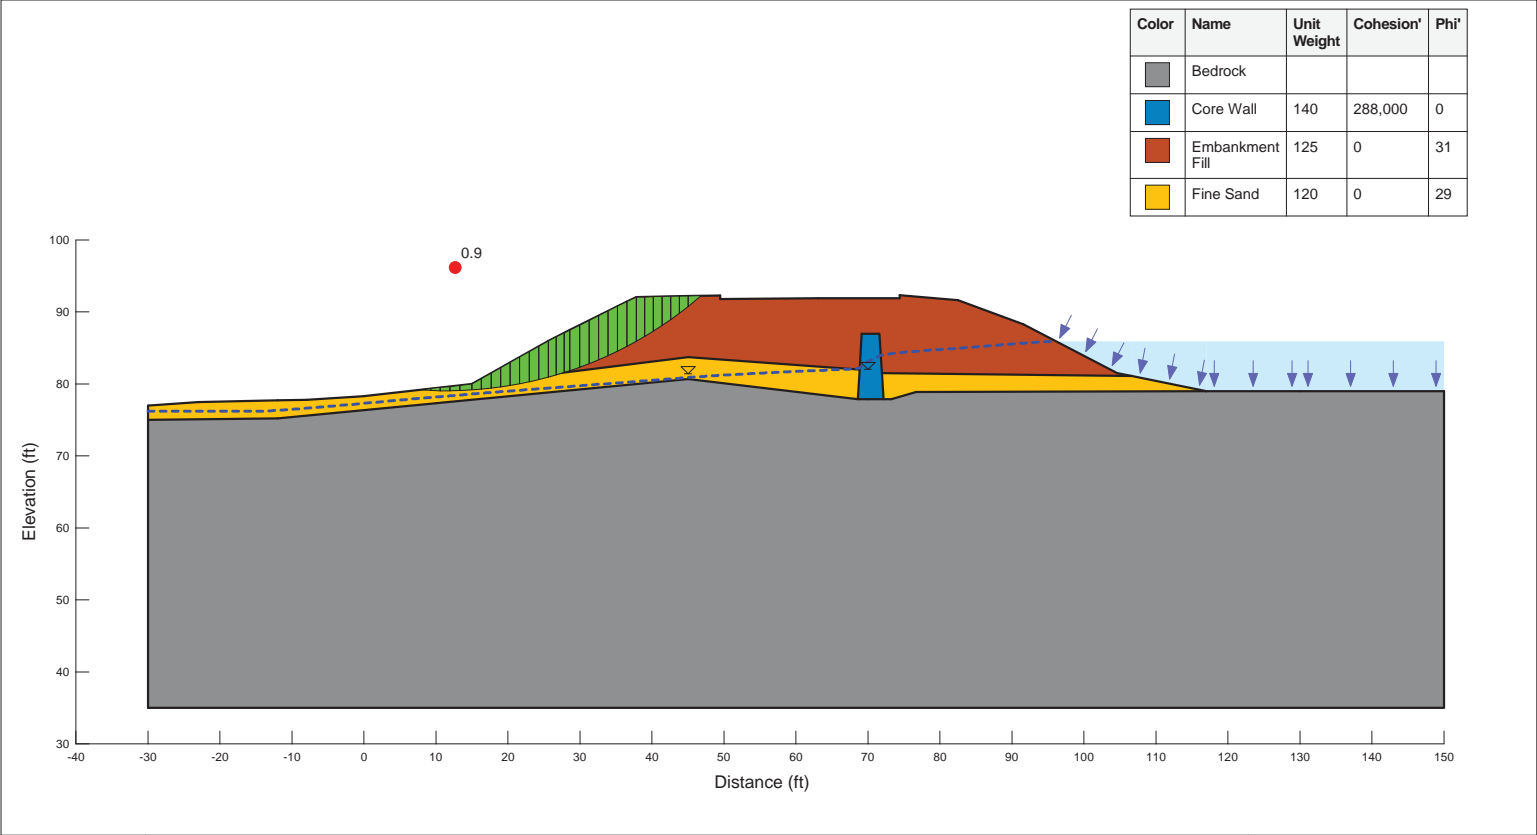
04/22/2020	Phase II For Bulloughs Pond Dam Newton, MA	FIGURE G-8
	Downstream Stability - Normal Pool (Psuedo-static Ag = 0.216)
